Customer: Vauxhall
Location: Ellesmere Port
Date: 14/09/11 and 20-09-2011

Intermittent “Hard Clutch” faults with press 1, which resulted in the Bed Cushion vibrating violently and causing downtime during the recovery process.

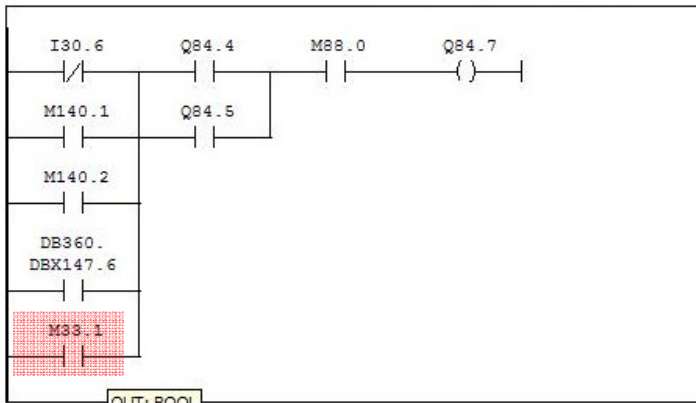
A modification has been made to press 1 PLC program (FC 123 network 4) to load the press 1 & 2 power pack whenever the line is ready for automatic. This has resulted in a suitable stable hard clutch pressure. The modification was monitored for 6 hrs with no adverse effects. Details of the modification added to the software change log on line 6.

Charge control clutch and slide locking press 1 and 2
m 33.1 added to stabilise clutch pressures. SPE 14-09-2011

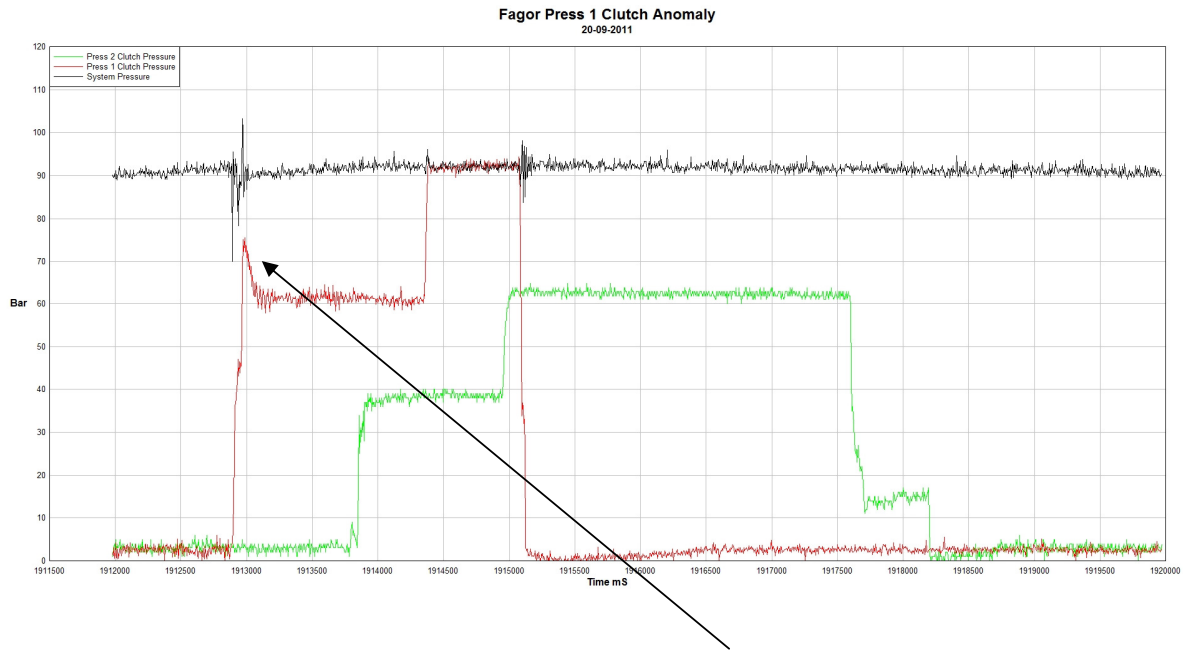
Fig 1.2

During these check we found an intermittent pressure pulse of up to 75 Bar during the soft clutch initiation phase of press 1. Oscilloscope traces proved that this pulse was being detected by the clutch monitoring pressure switch (W12-S 42.02), this results in a false hard clutch engaged signal being sent to the press safety PLC with subsequent immediate removal of the clutch valve signals.

Pressure Switch Settings	Old	Current
SP1	73 Bar	69 Bar
RP1	80 Bar	69 Bar
Dap	3 milli-Seconds	30 milli-Seconds

Changed pressure switch settings, to prevent unintended switch operation. The system was then monitored for several more hours at 17.2 SPM. Two more occurrences of the pressure peak were detected without stoppage of the press.
